# TECHNICAL REPORT TR-NAVFAC-EXWC-CI-1301

# CPC PROGRAM FINAL REPORT ELECTRICAL RESISTANCE PROBE CORROSION SENSORS FOR IN-SITU ASSESSMENT FOR WATERFRONT STRUCTURES FY09 OSD PROJECT F09NV04

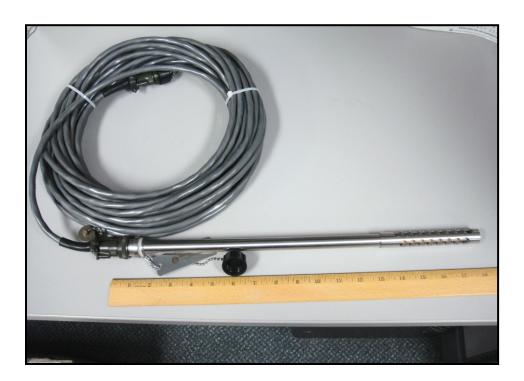
**Figure 2-1.** Typical ER probe used for this project.

*Figure 2-1* illustrates the fixed process probe that was selected for this study. This ER probe has a thin walled cylindrical sensing element which is welded onto a body of the same material. No other materials are in contact with the corrosive medium. Welds are vacuum annealed during assembly to minimize corrosion effects. The probe may be used in aggressive organic or inorganic fluids over the entire pH range.

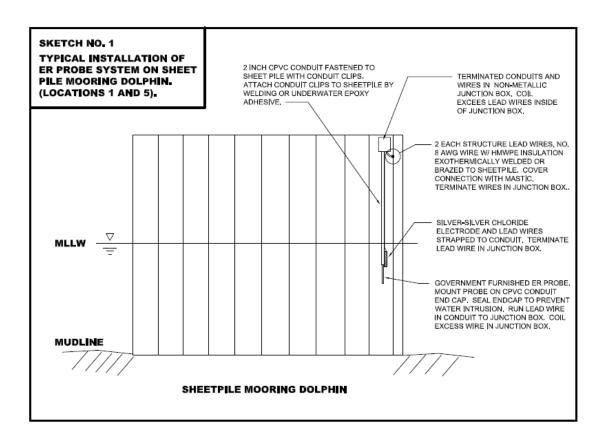
Figure 2-2. Schematic of ER probe installation

ER probes with a ten (10) year instead of the two (2) year life indicated in the project plan (Appendix A) were selected to account for exposure to the highly corrosive seawater environment and effects of stray current from the high output current CP system before the probes were connected to the CP system. The ER probes and structure terminal connections were installed, at five prescribed locations three feet below mean low tide level on selected H-piles and sheet piles at the Delta/Echo Piers. *Figure 2-2* illustrates a typical installation.

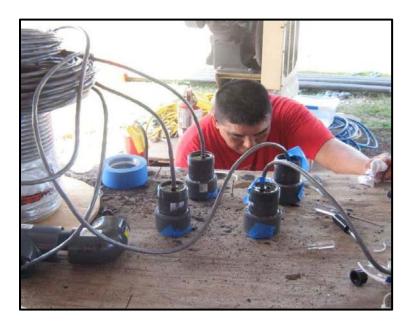
**Figure 2-3.** Encapsulation of probe connectors. Not visible are the probe bodies extending through holes in the work surface

Protection of the probe connectors from exposure to moisture was paramount as failure of the connector would render the probe useless. The electrical connector between the probe and the test wires was encapsulated with epoxy in a plastic conduit on-shore prior to installation to prevent exposure of the connector to the saltwater and protect the connection from corrosion (*Figures 2-3 and 2-4*).

- Encapsulate the probe connection to the lead wire. It is imperative to do this for submerged applications to prevent water intrusion and corrosion of the connection.

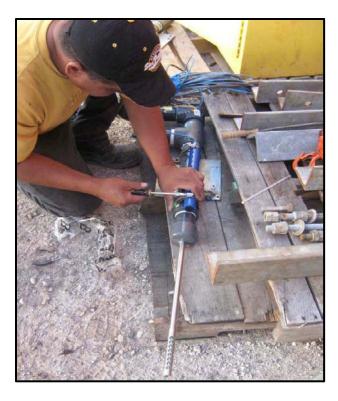
**Figure 2-5.** Probe with attached silver-silver chloride reference electrode (blue tube)

A secondary monitoring system was provided for the ER probe installation on the pier to serve as a comparison. The secondary monitoring system included the installation of a standard SSC reference electrode in close proximity to each ER probe as shown in *Figure 2-5*.

The completed probe/silver chloride reference electrode assembly was mounted to the planned submerged sections of electrical conduit on shore prior to installation, again, to prevent water intrusion into the conduit system (*Figure 2-6*). The intent of this process was to ensure that this assembly would be installed such that an open end of the conduit system would not be submerged below water during installation, thereby minimizing water intrusion into the conduit system.

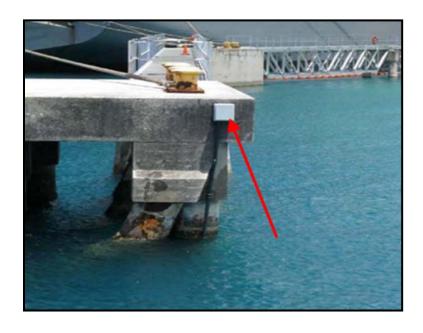
**Figure 2-7**. Typical test box (red arrow)

The test wires for the SSC electrodes were run together in the conduit system with the ER probe test wires and two structure test lead connections to a conveniently located terminal box (*Figure 2-7*). This overall monitoring system would allow the ability to test/correlate the test results from the ER probe and a standard SSC electrode. The test box would also serve as a connection point between the probe and the protected structure after the effects of stray current interference were evaluated. A control probe was installed nearby the pier, but outside the influence of the pier CP system.

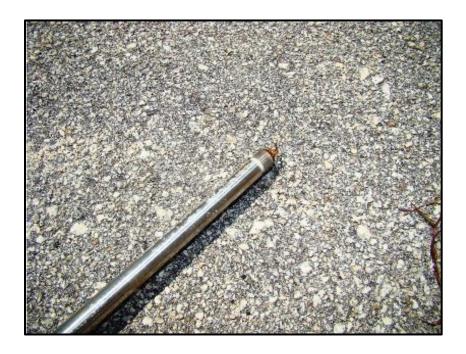
**Figure 3-1.** Damaged control probe. Note missing probe tip.

A control probe, No. 635, was installed in the vicinity, but outside the influence of the pier CP system. The intent of the control probe installation was to measure the free corrosion rate of the probe outside the influence of cathodic protection and its stray current effects. A few months after installation, the control probe tip was found physically damaged for causes unknown (*Figure 3-1*). A second control probe was installed, but without the epoxy encapsulation of the electrical connector between the probe and the test wires. This probe subsequently failed due to corrosion of the electrical connector (*Figure 3-2*). Corrosion products on the connectors introduce additional resistance into the probe measuring circuit. Since the resistance of an ER

- [1] Probes installed March 2010 by Shaw Environmental.
- [2] Control probe installed in April 2010.
- [3] Meter probe check failed. Removed September 2010 and found physically damaged.
- [4] Probe corroded past useful life. All remaining functional probes connected to the CP System.
- [5] Meter probe check failed. Cause unknown.

- Select and install probes in locations to preclude physical damage. Avoid locations where floating debris and day to day operations can result in damage to the probes or test wiring system.

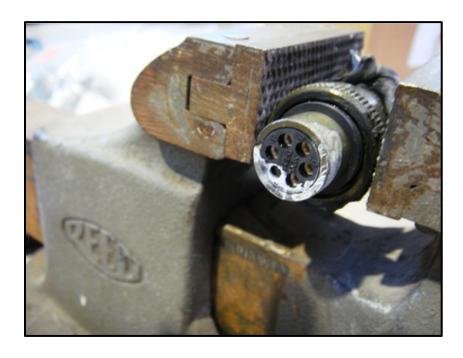
Figure 3-2. Corrosion of ER Probe Connector.

Metal loss from the probes is cumulative over time. The electrical resistance meter measures the resistance and an algorithm calculates the cumulative corrosion rate over the period of time since the first measurement. Corrosion rates increased significantly shortly after the CP systems were energized due to the anticipated stray current effects. After the probes were connected to the CP system, the corrosion rates of the functioning probes have significantly declined and were still declining to date. The declining corrosion rates suggest that the CP system has mitigated corrosion of the probes, and the cumulative corrosion rates are anticipated to continue to decrease to negligible rates with time. The corrosion rate for probe No. 634 indicated a very low corrosion rate as compared to probe Nos. 627 and 633 after 12 months. This probe subsequently failed for causes unknown, although it is suspected that the electrical connector between the probe and test wire has failed similarly to the second control probe.

- For applications where the ER probe will be submerged, it is imperative that every effort be taken to prevent water intrusion into, and the subsequent corrosion of the connector between the probe and its lead wire.

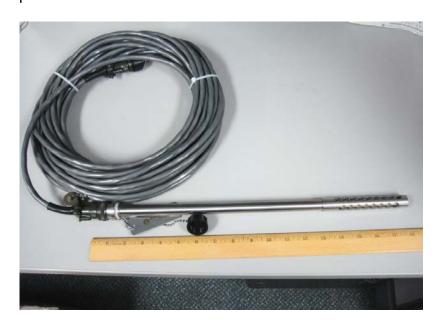
• Rohrback Cosasco electrical resistance probe. The shaft of the probe is about 18 inches long with a ¾" connector to the cable. 50 feet of connecting cable will be provided.
